Concrete Manhole

Category: Corrosion Protection

Customer: City of Portland, OR

Project: Protect concrete manhole from hydrogen sulphide attacks in sewer wastewater

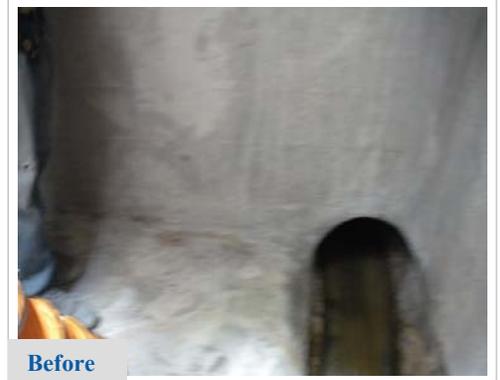
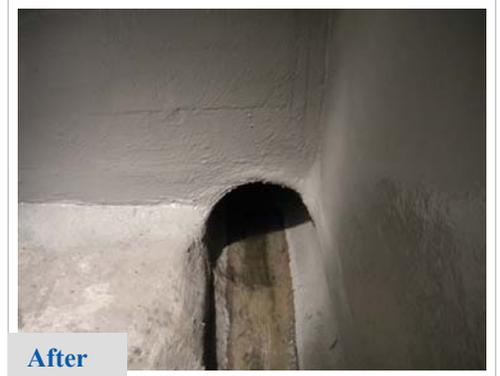
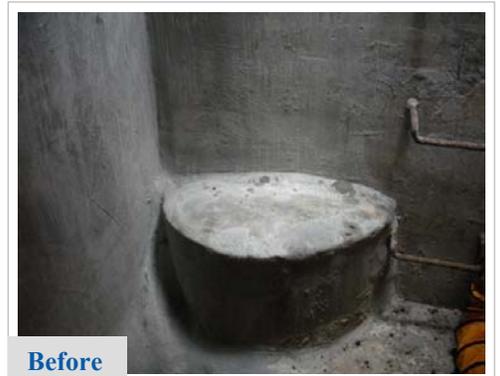
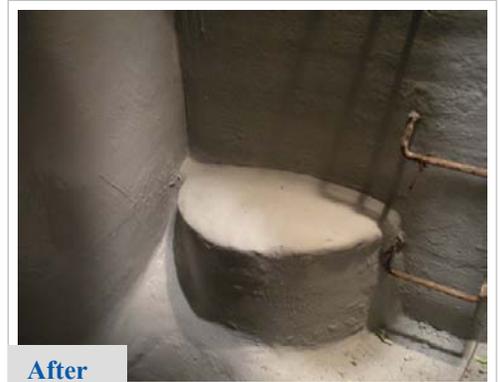
The city of Portland, OR was experiencing severe manhole concrete spalling from hydrogen sulphide corrosion and cracking from the effects of natural ground movement. The structure had been deteriorating over the past 10 years and the repair needed to be done in near 40° winter temperatures.

To ensure continued protection against future hydrogen sulphide attacks, the entire 200 Sq. feet of the manhole's walls, ceiling and benches were sprayed with Rhino Extreme at variable thicknesses ranging from 1/4" to 3/8", depending upon expected H₂S exposure levels.

Rhino Linings primers and liner were used on the entire manhole surface area. **Primer 101 (epoxy)** was used as a moisture barrier to the concrete. **Primer 161 (polyurethane)** was chosen because of its high elongation, adhesion and bonding properties. **Rhino Extreme (polyurea)** liner was selected because of its ability to be sprayed in low temperatures, its excellent protection against impacts and abrasion, and its 450% elongation properties.

Operationally, Iron Horse repaired the spalled concrete and smoothed out the cracks and holes caused by the hydrogen sulphide corrosion in one-half day. They applied the Rhino 101 and 161 primers and sprayed Rhino Extreme throughout the manhole in another day. The entire job was done at temperatures near 40° F with the inside humidity at 50% using a portable heater to cure the primers. Rhino Extreme provided a fast cure and quick return-to-service because of its moisture/temperature resistant properties.
